MARYLAND INVENTORY OF HISTORIC BRIDGES HISTORIC BRIDGE INVENTORY MARYLAND STATE HIGHWAY ADMINISTRATION/ MARYLAND HISTORICAL TRUST

MHT No. <u>BA-2674</u>

SHA Bridge No. B 0138 Bridge name Gores Mill Road over Little Falls
LOCATION: Street/Road name and number [facility carried] Gores Mill Road
City/town Middletown Vicinity X
County Baltimore
This bridge projects over: Road Railway Water X Land
Ownership: State County X Municipal Other
HISTORIC STATUS: Is bridge located within a designated historic district? Yes NoX
Name of district
BRIDGE TYPE: Timber Bridge: Beam Bridge: Truss -Covered Trestle Timber-And-Concrete
Stone Arch Bridge
Metal Truss Bridge _
Movable Bridge: Swing Bascule Single Leaf Bascule Multiple Leaf Vertical Lift Retractile Pontoon
Metal Girder: Rolled Girder: Rolled Girder Concrete Encased Plate Girder: Plate Girder Concrete Encased
Metal Suspension
Metal Arch
Metal Cantilever
Concrete X : Concrete Arch : Concrete Slab X Concrete Beam : Rigid Frame : Concrete Slab X Concrete Beam : Rigid Frame : Concrete Slab X Concrete Beam : Rigid Frame : Concrete Slab X Concrete Beam : Rigid Frame : Concrete Slab X Concrete Beam : Rigid Frame : Concrete Slab X Concrete Beam : R

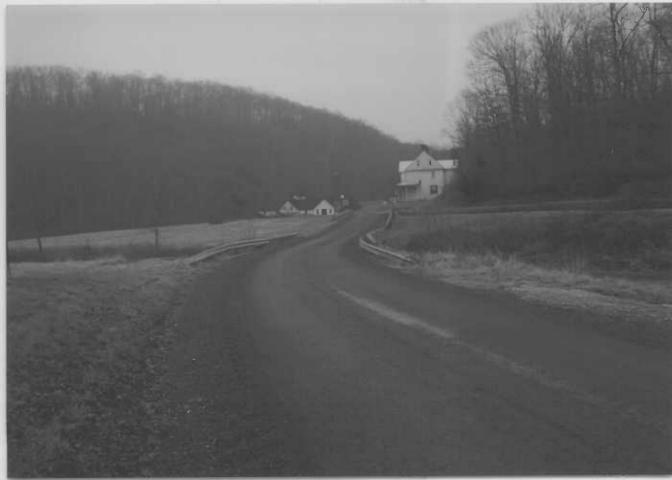
Inventory # <u>BA-2674</u>	
Name 18138 - GORES MILL RD OVER LITTLE FALLS County/State BATTIMURE COUNTY MO Name of Photographer DAVE DIEHL	>
Date 195 Location of Negative 5HA	
Description WEST APPROACH LODKING	
KAST	
Number 8 of 247

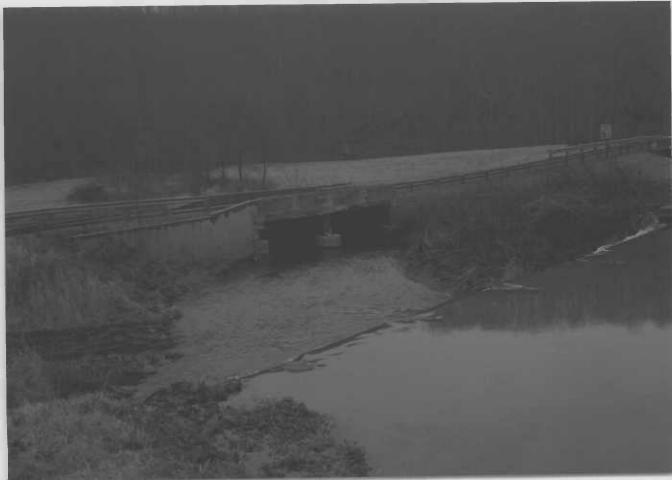
Inventory # <u>BA-26</u>74

Name of Pho	otographer DAVE DIEHL
Location of	Negative SHA
Description	SOUTH ELEVATION LOOKIN

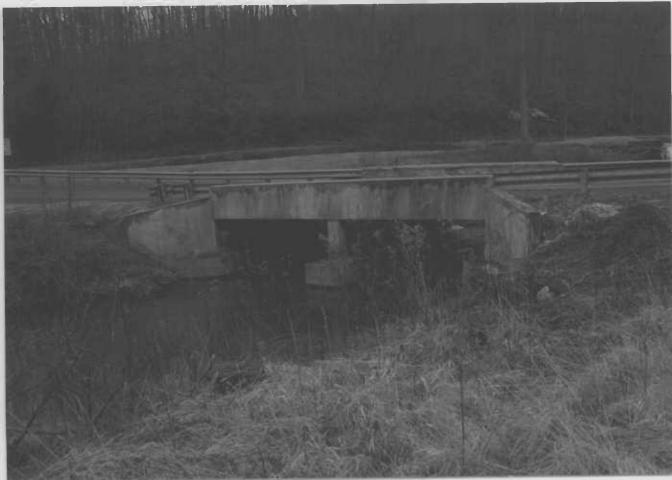
Inventory # Bk - 2674

Name BOISB-GORES MILL RD OVER LITTLE FALLS
County/State BALTIMORE COUNTY/MD
Name of Photographer DAVE DIEHL
Date 1/95
Location of Negative SHA
Description NORTH ELEVATION LOUKING
South
2 7
Number 18 of 24

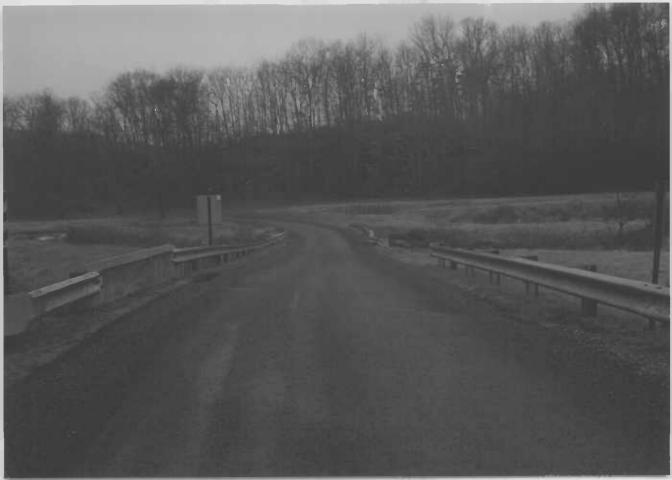
Inventory # BA - 2674

Description EAST APPROACH LOOKING WEST
